RE: **Annual Operation Report for 2020**  
**Frey Farm Landfill, Permit No. 101389**

In accordance with the Municipal Waste Management Regulations (Section 273.313) enclosed herein is the Annual Operation Report relating to the above referenced facility.

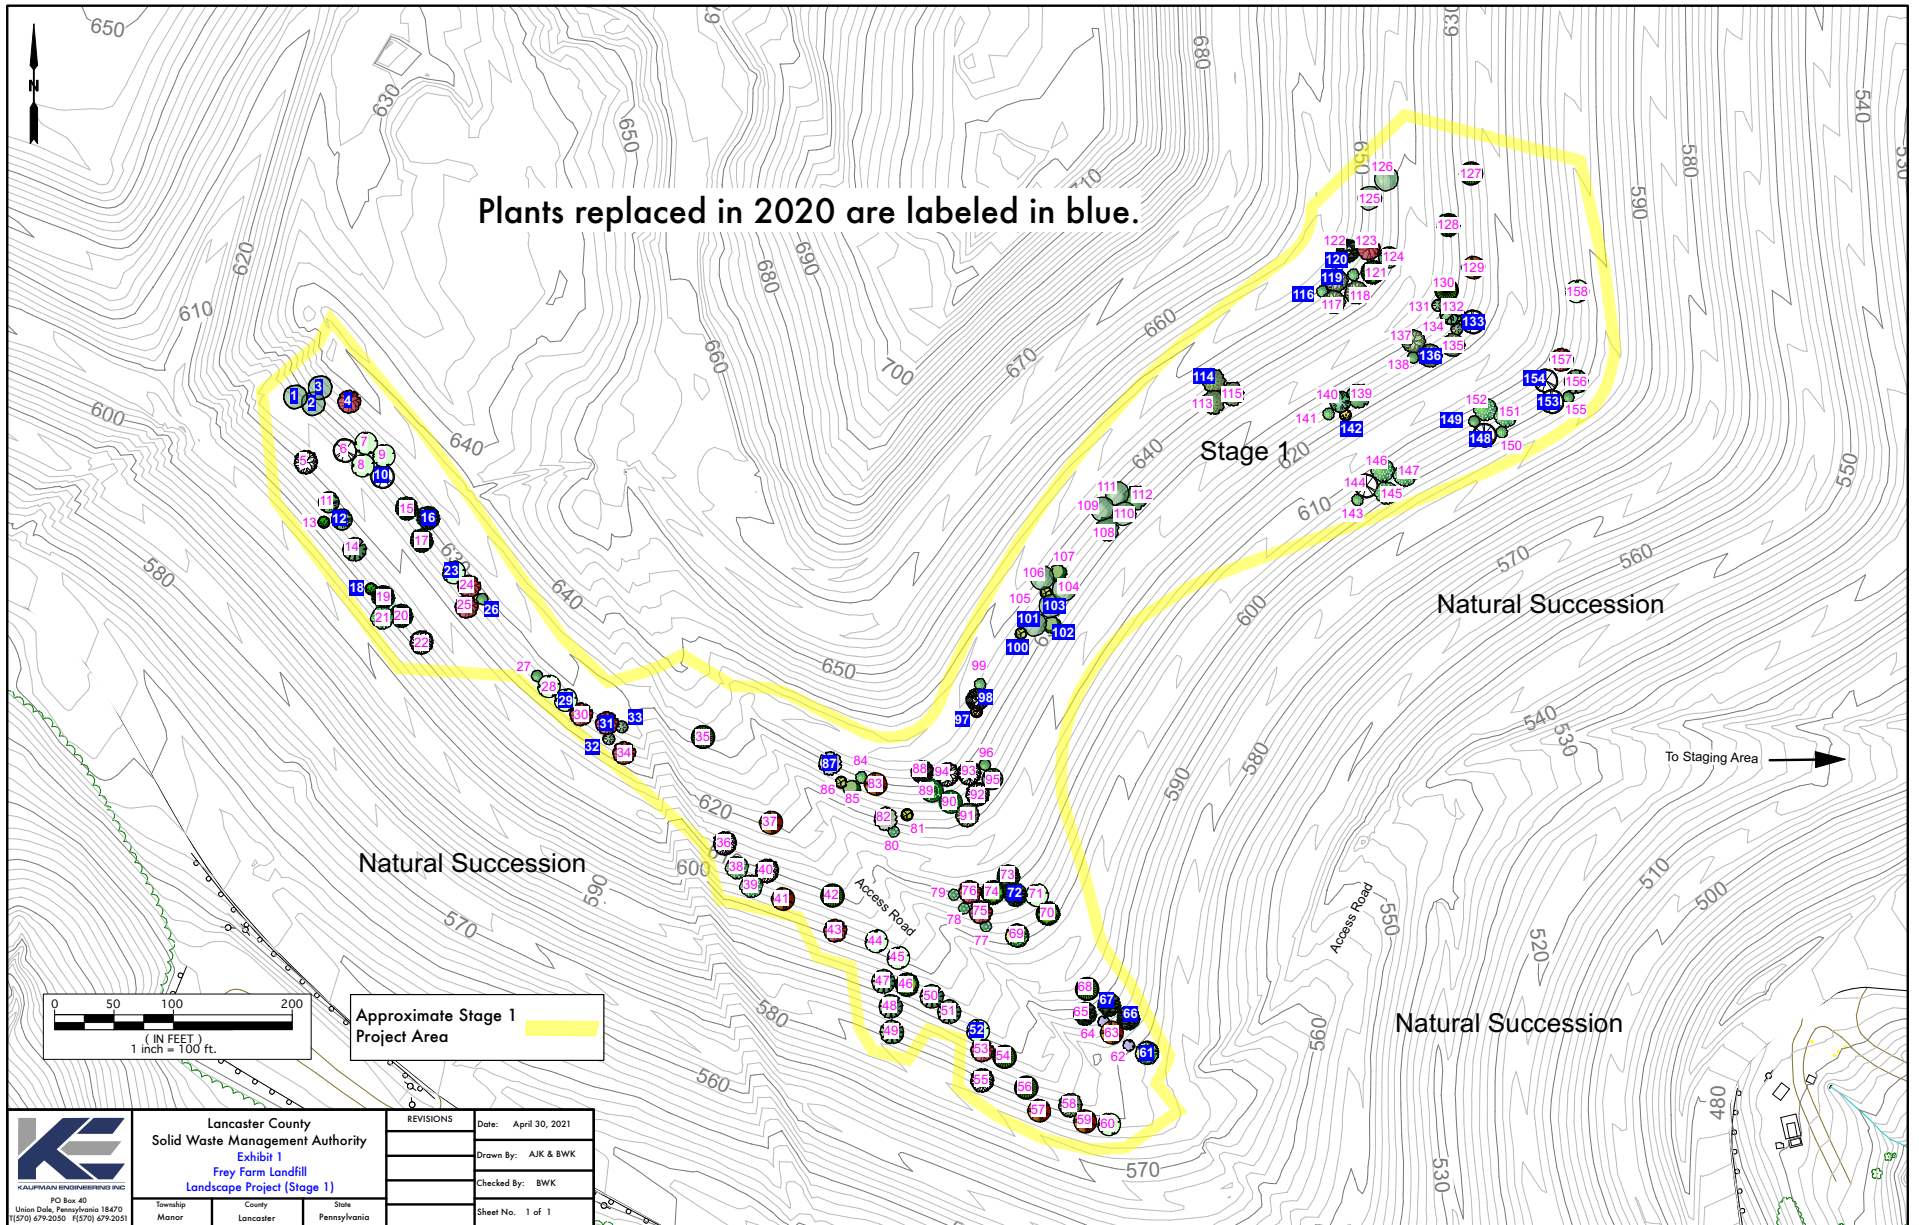
During Early October - Site Contractors, in an effort to cap the area directly above the northwestern edge of "Stage One" had unavoidable impact on plants 1, 2, 3, 4, 10, 16, 23, 26, 29, 31, 32, 33. In order to complete the proper capping and grading of this area, these plants were removed. LCSWMA used this opportunity to replace and mitigate the lost plant material with plant material of a larger size and caliper and with species thought to be thriving in our first year of analysis. (A list of effected plant material and replaced plant material is attached). The replacement plants were implemented during October 2020 and observed during this inspection.

Stage One Overview - Plant Numbers (Plants Shown in Blue Were Replaced in 2020)

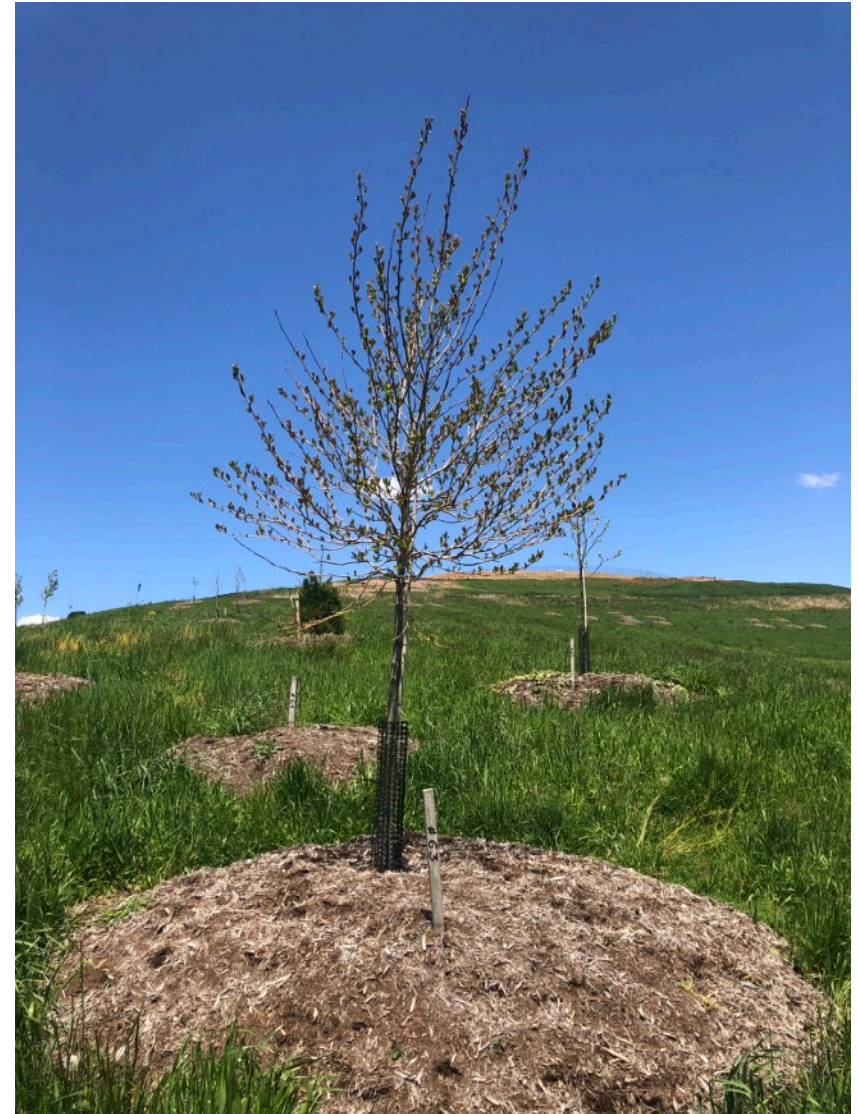
**Photo 7** – A Black Gum tree. Mulch has faded becoming more natural. Note deer protection and tree identification stakes.

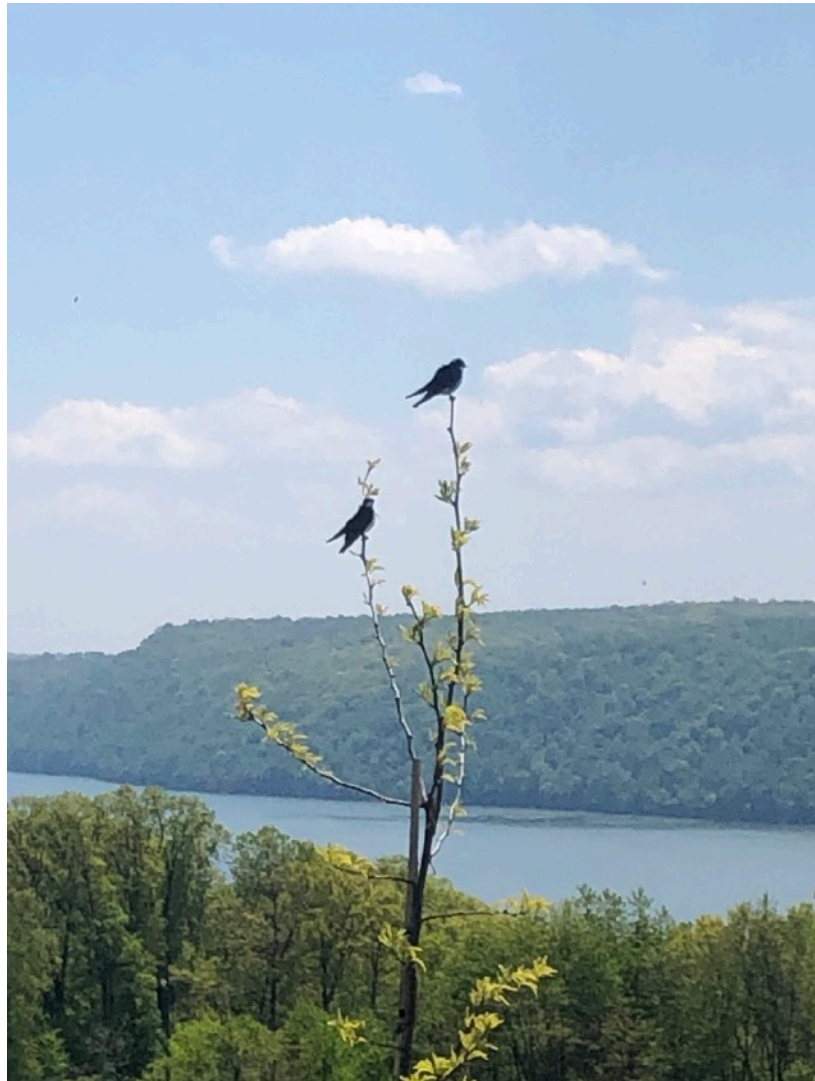
**Photo 8**– Frequently observed many birds utilizing new habitat.

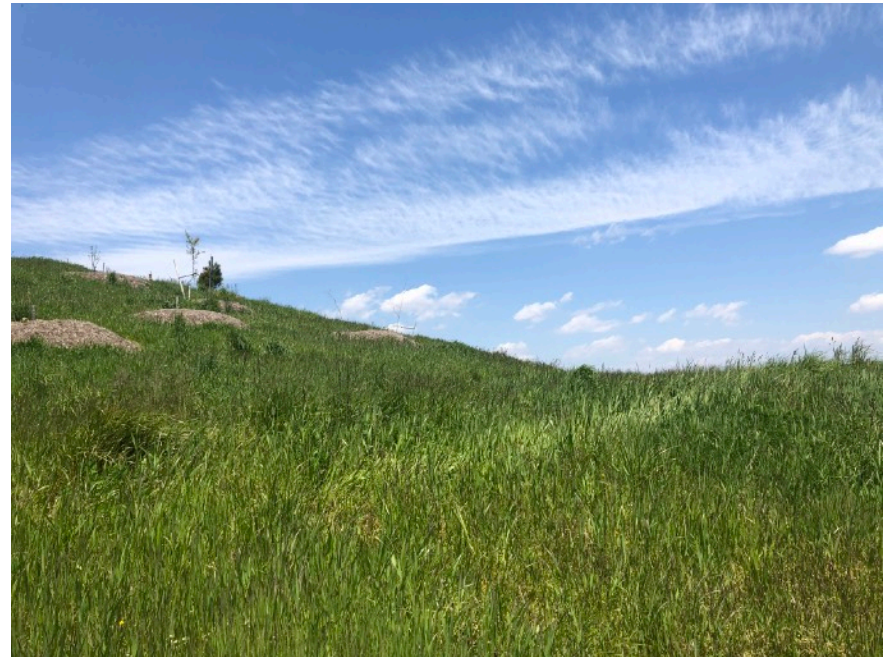
**Photo 9** – Natural Succession beginning to soften engineered appearance of landfill benching.
