2022 LCSWMA Frey Farm Landfill Annual Operational Report"

June 27, 2023

RE: **Annual Operation Report for 2022**
Frey Farm Landfill, Permit No. 101389

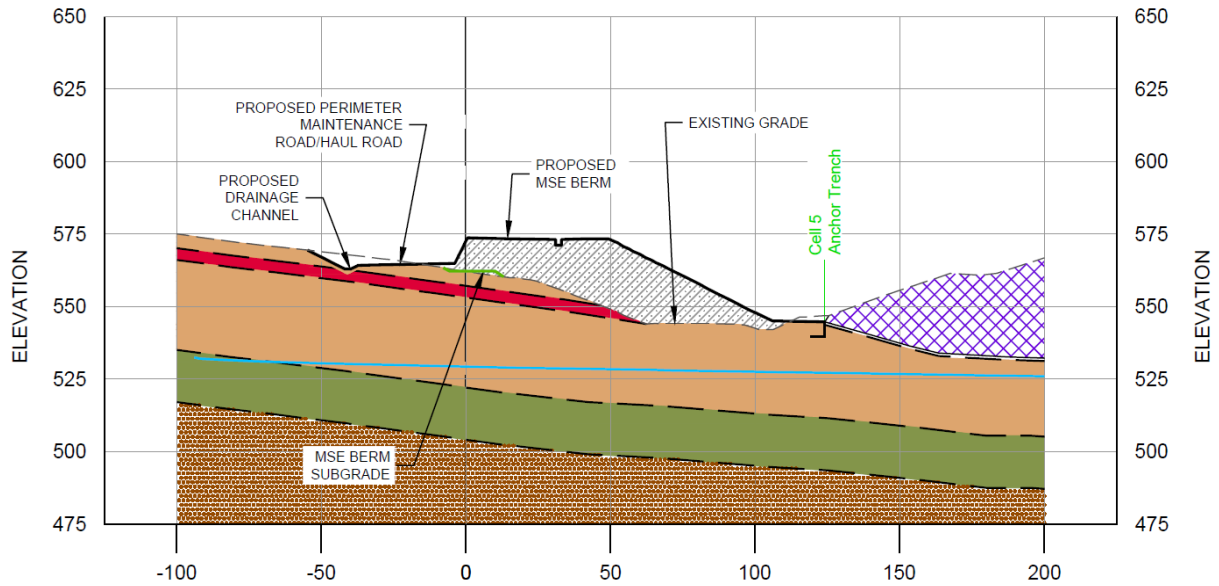
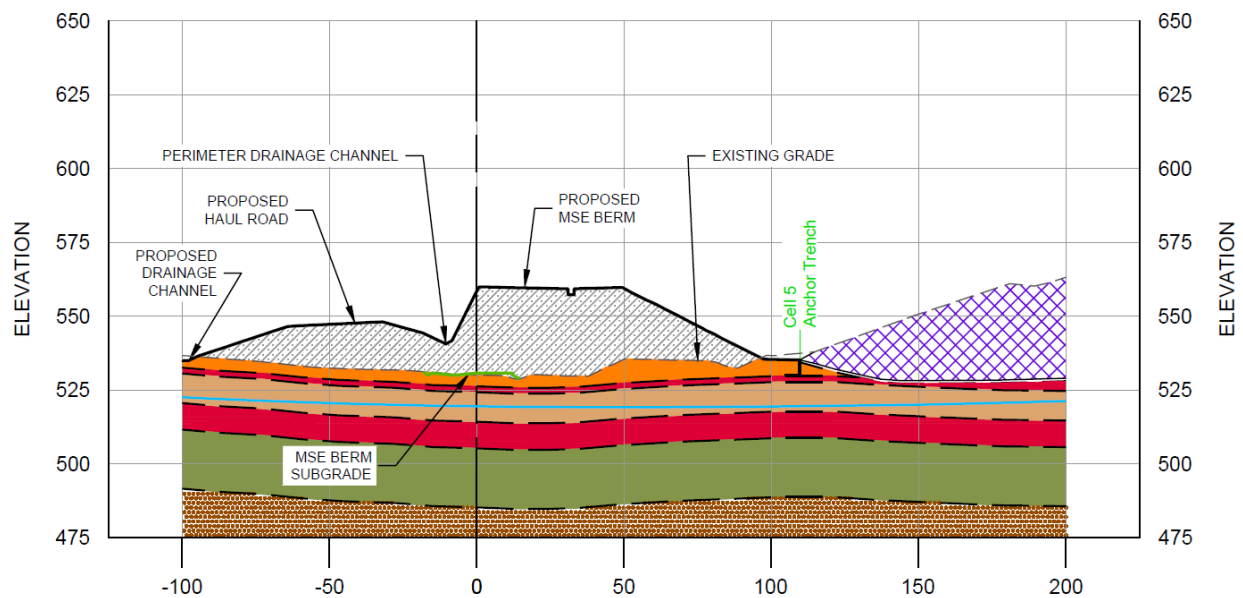
It should be noted that the changes in elevation at STA 20+00 and 22+00 along the toe of the berm do show more significant settlement than the rest of the monitoring points. The settlement is likely due to the phasing and sequencing of construction. After the MSE berm was constructed, additional structural fill was placed along the face of the MSE berm in this area to construct the new landfill haul road. Therefore, the control monuments were installed within the additional structural fill, which is more prone to settlement than the MSE berm, especially at the interface of the MSE berm and structural fill, where compaction of the subsequently placed structural fill would be more difficult due to the presence of the MSE berm welded wire forms. Below are two cross-sections at STA 20+00 and 22+00 showing the bottom of the MSE berm and the structural fill placed along the outside of the MSE berm.
