"2021 LCSWMA Frey Farm Landfill Municipal Waste Landfill Annual Operation Report"

### RE: Annual Operation Report for 2021 Frey Farm Landfill, Permit No. 101389

# PA DEP ANNUAL OPERATION REPORT

# FREY FARM LANDFILL

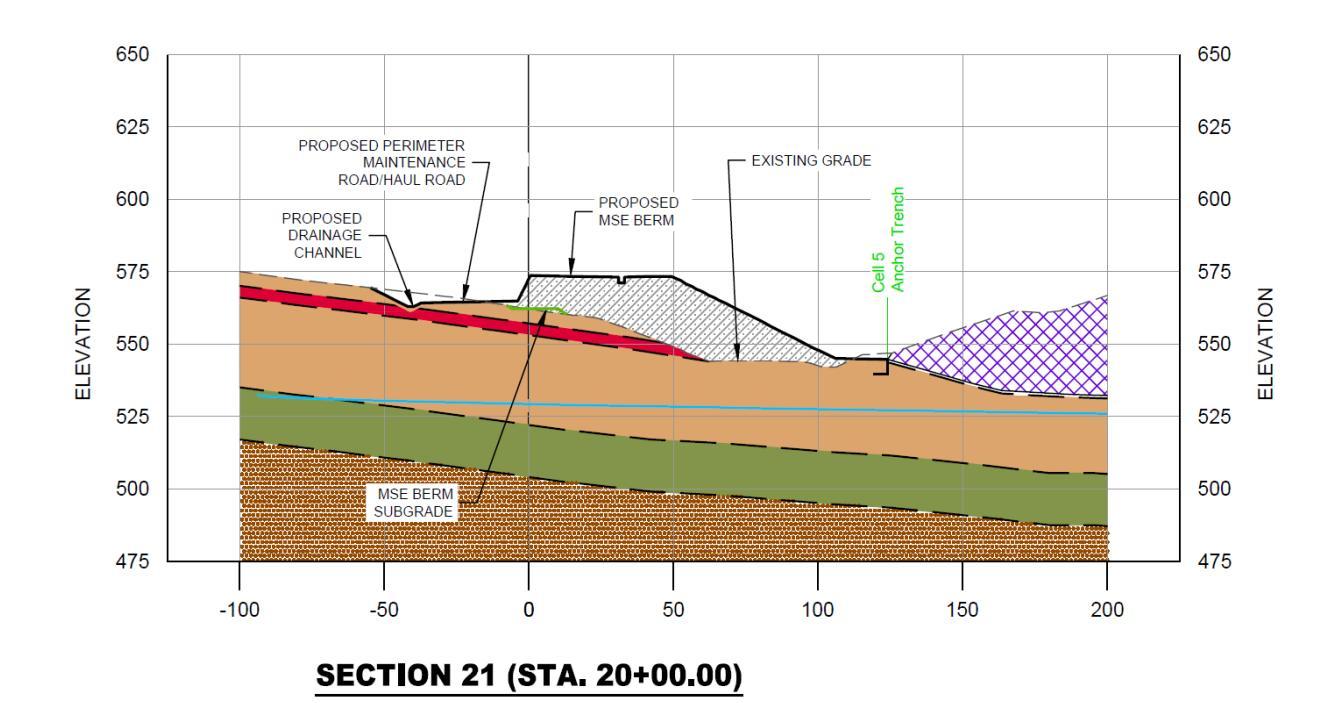
It should be noted that the changes in elevation at STA 20+00 and 22+00 along the toe of the berm do show more significant settlement than the rest of the monitoring points. The settlement is likely due to the phasing and sequencing of construction. After the MSE berm was constructed, additional structural fill was placed along the face of the MSE berm in this area to construct the new landfill haul road. Therefore, the control monuments were installed within the additional structural fill, which is more prone to settlement than the MSE berm, especially at the interface of the MSE berm and structural fill, where compaction of the subsequently placed structural fill would be more difficult due to the presence of the MSE berm welded wire forms. Below are two cross-sections at STA 20+00 and 22+00 showing the bottom of the MSE berm and the structural fill placed along the outside of the MSE berm.
