RE: **Annual Operation Report for 2020**  
**Frey Farm Landfill, Permit No. 101389**

In accordance with the Municipal Waste Management Regulations (Section 273.313) enclosed herein is the Annual Operation Report relating to the above referenced facility.

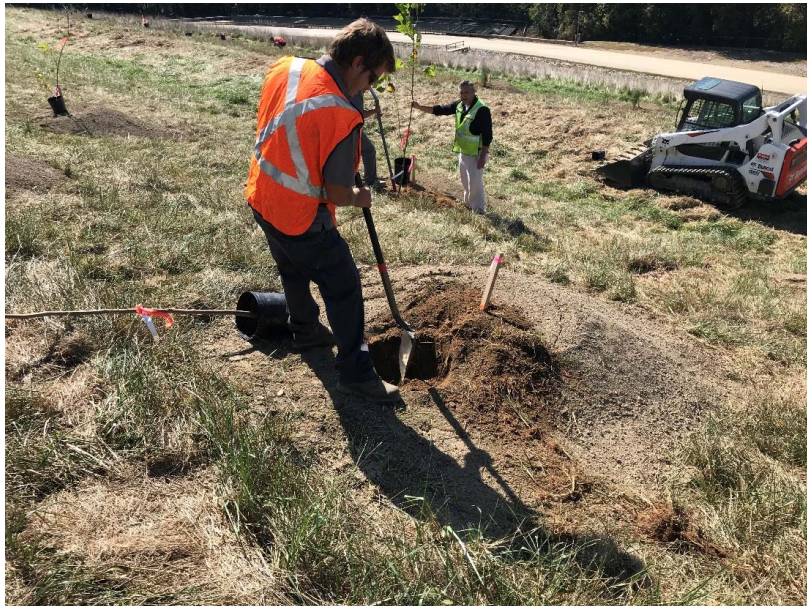
**Photo 2** – Tomlinson Bomberger performing planting of the Phase 1 trees.  
All trees were planted with hand tools and monitored for planting depth by ARM.
