2022 LCSWMA Frey Farm Landfill Annual Operational Report"

June 27, 2023

RE: **Annual Operation Report for 2022**
Frey Farm Landfill, Permit No. 101389

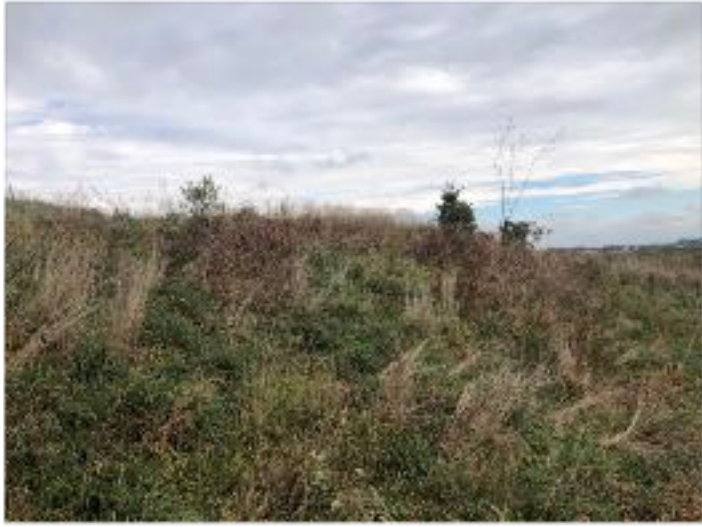
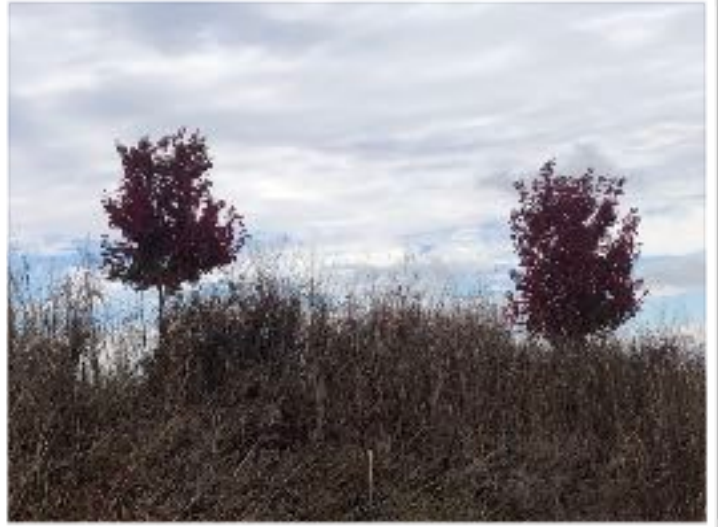
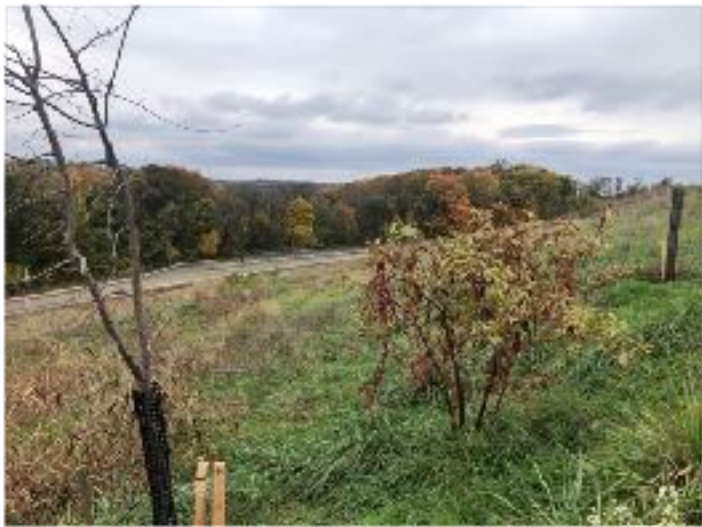
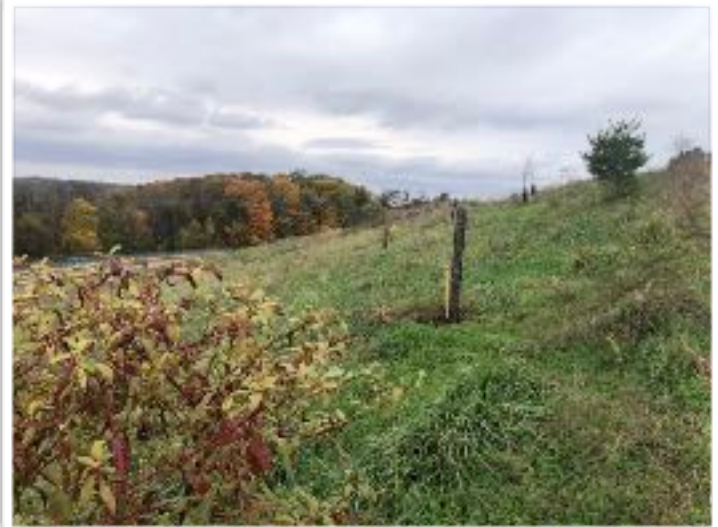
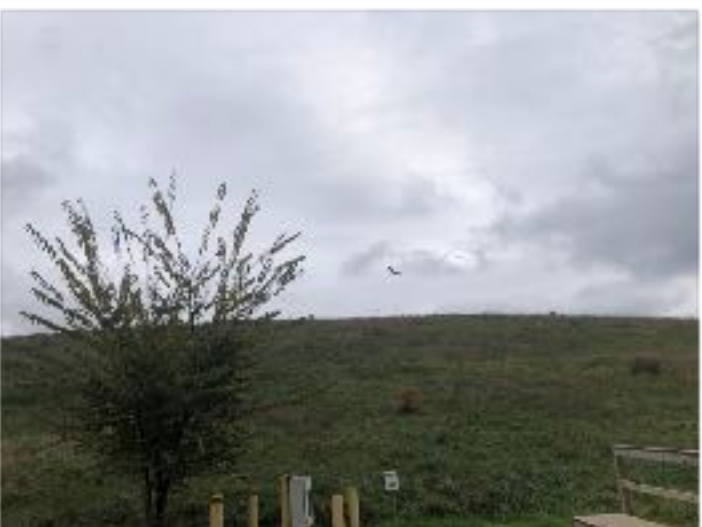
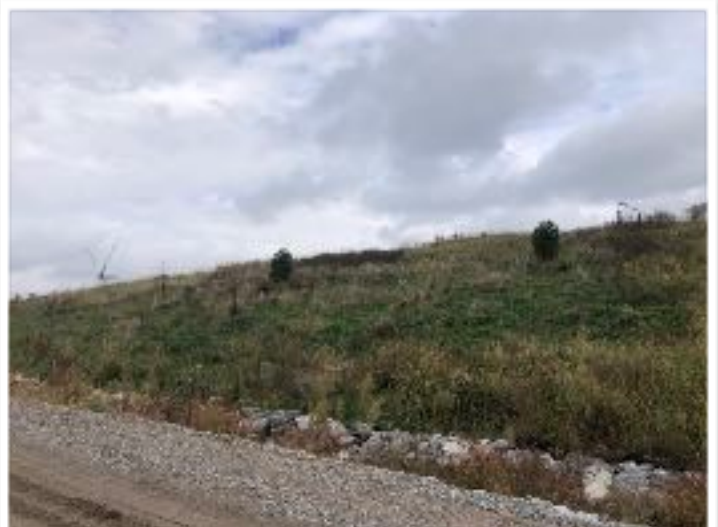
Photos Taken During
October 2022 Inspection

Deer (buck) damage was once again observed on many trees. Larger deer guards were re-installed or adjusted to try and create additional protection to thwart heavy damage. Jeff Musser has documented a large deer (buck) population on a game camera that has been placed onsite. Natural succession zone ranges 18" - 72" in height. Slopes appear full with grasses thriving. Continue to be very pleased with visual softening of benching and greater visual appeal when contrasted with traditional mowed slope aesthetic. Continued, seasonal, visual interest and texture, matching surrounding "buffer" landscapes will now likely continue on seasonal basis. Not recommending replacing plants at this point. As noted above we did replace (36) pieces of plant material accross the expanding population of Stage 1 and Stage 2. I've listed the replacement plant material here for reference.

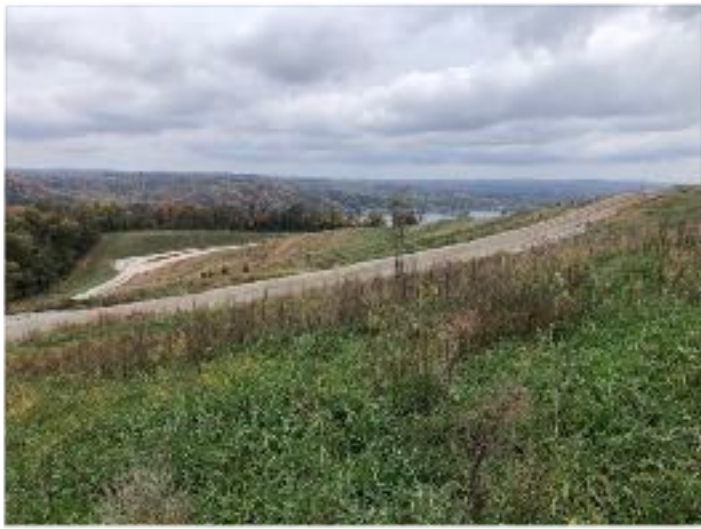
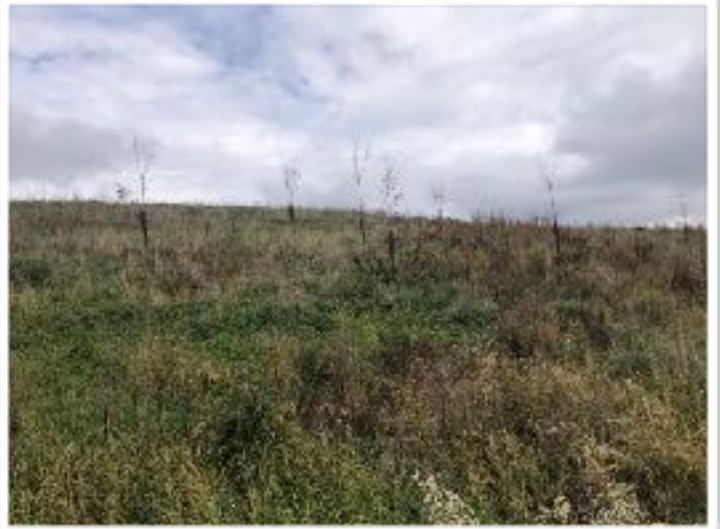
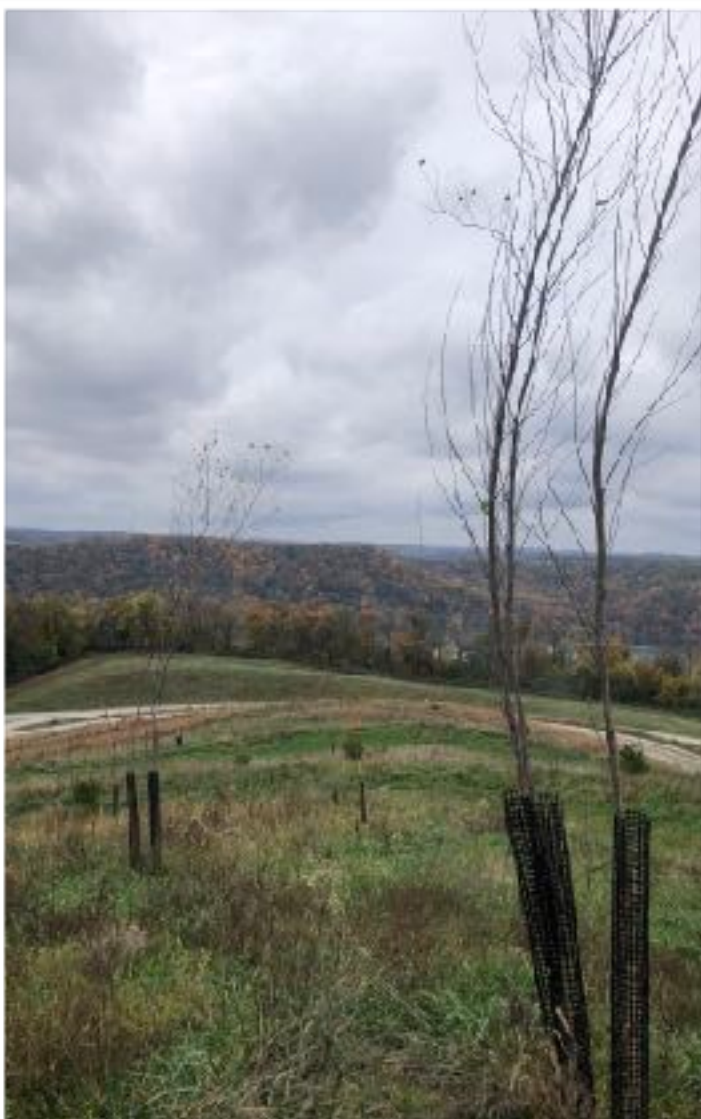
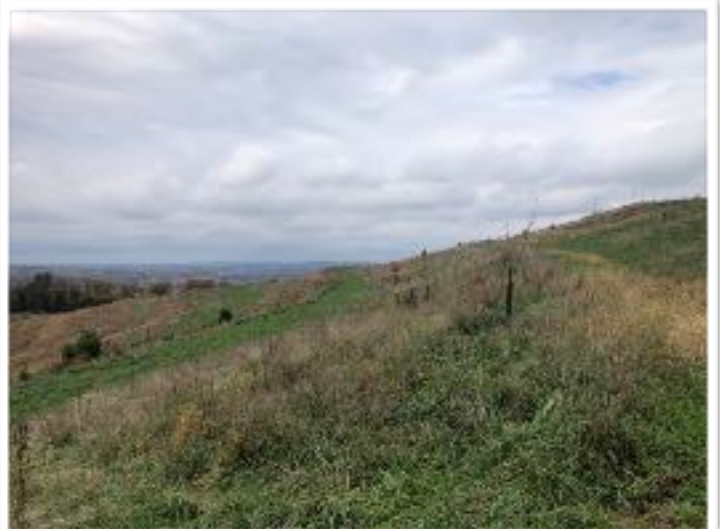
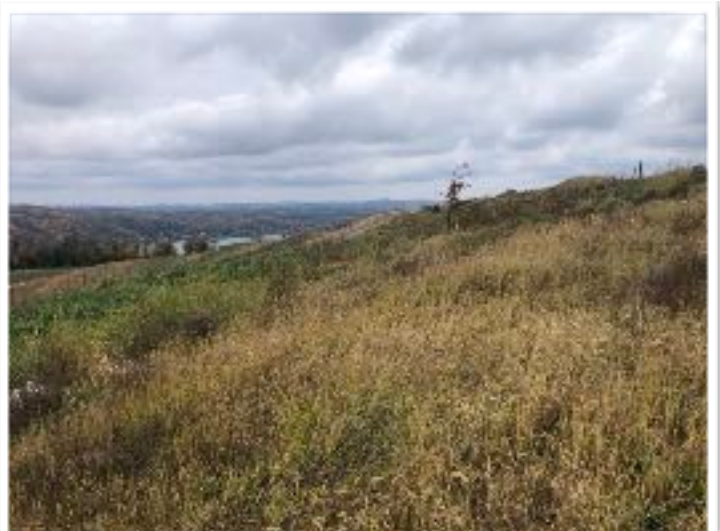
Photos Taken During
October 2022 Inspection

*		A portion of tree and shrub population was removed and replaced on October 12th, 2022. (36) replacement plants were planted on Oct. 12th 2022. Damaged plants were from deer damage or dought stress that did occur this summer

*	Weed growth continues to be aggressive around the base of many trees and shrubs. Continue to recommend weed contrall around base of plants withing Stage 1 and 2 to allow plants to thrive. Care should be given to not damage bark around base of any plant material during weeding.
