RE: **Annual Operation Report for 2020**  
**Frey Farm Landfill, Permit No. 101389**

In accordance with the Municipal Waste Management Regulations (Section 273.313) enclosed herein is the Annual Operation Report relating to the above referenced facility.

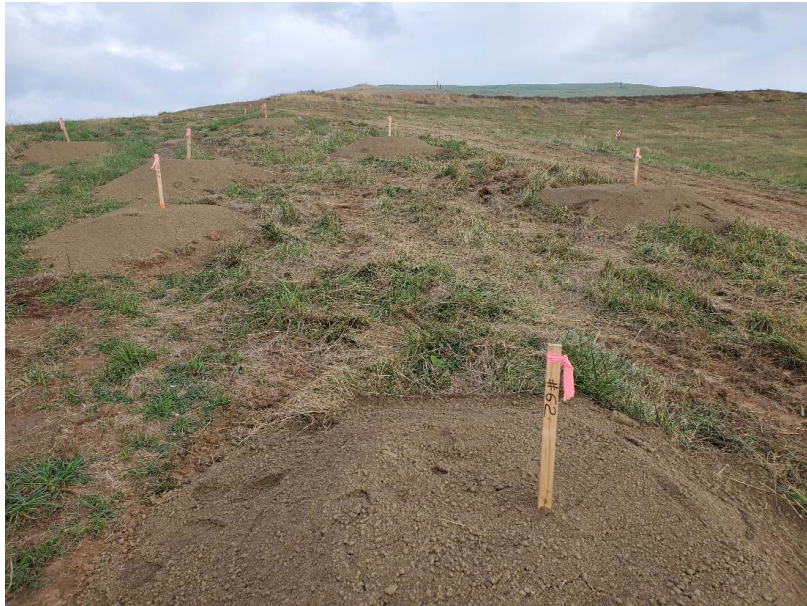
**Photo 1** – Crown Excavating installed mounds of topsoil in the surveyed Phase 1 locations.

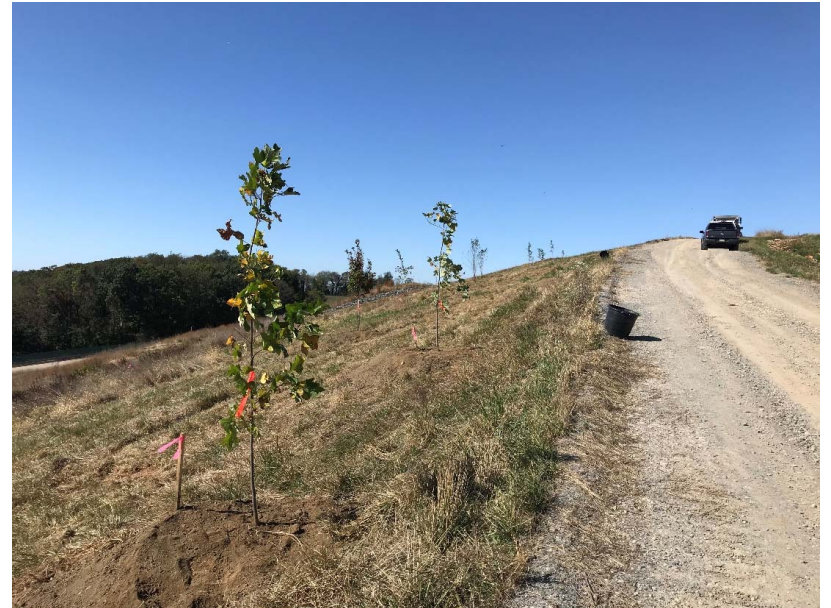
**Photo 3** – Day 1 planting observation progress picture.

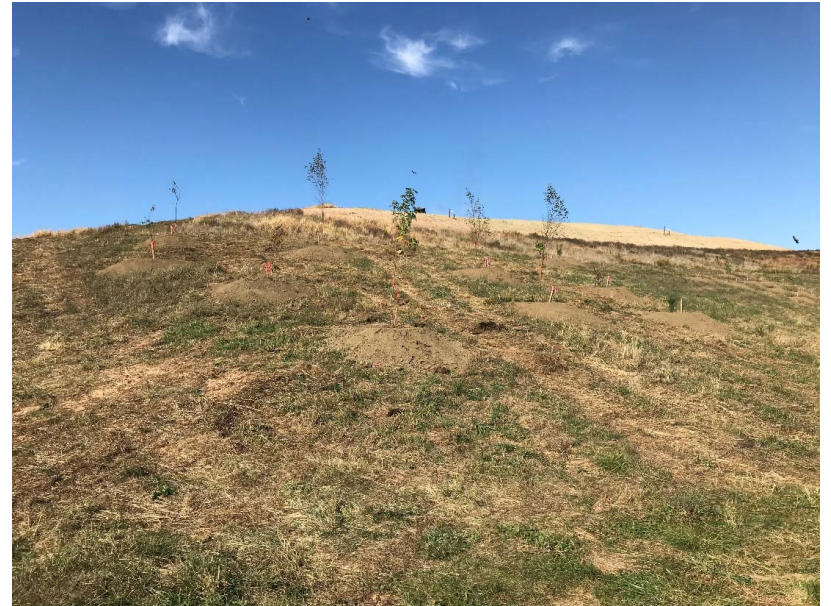
**Photo 4** – Day 2 planting observation progress picture.

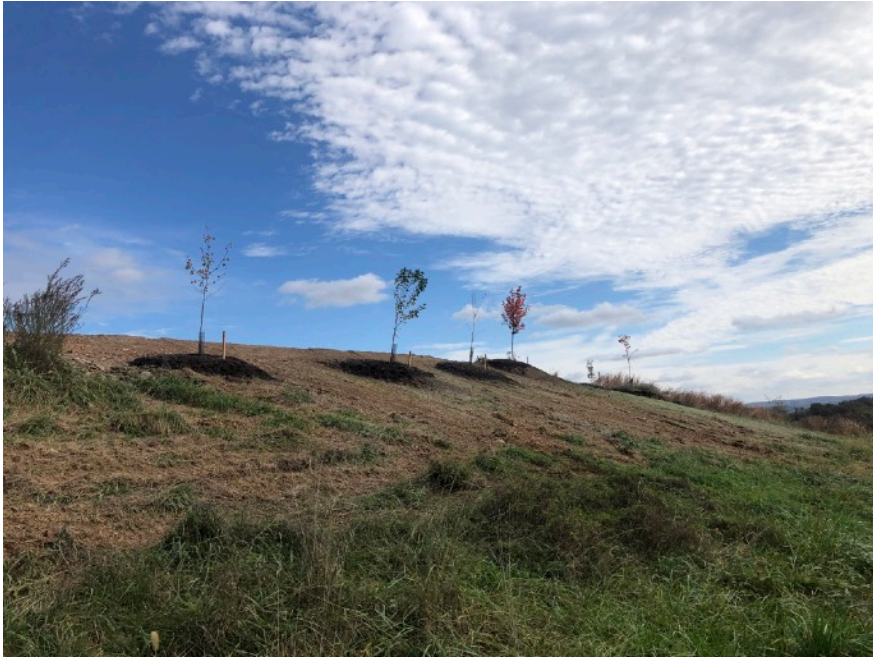
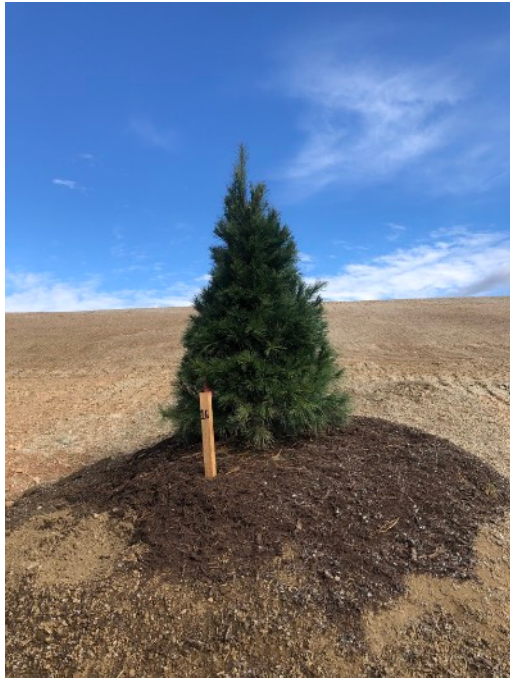
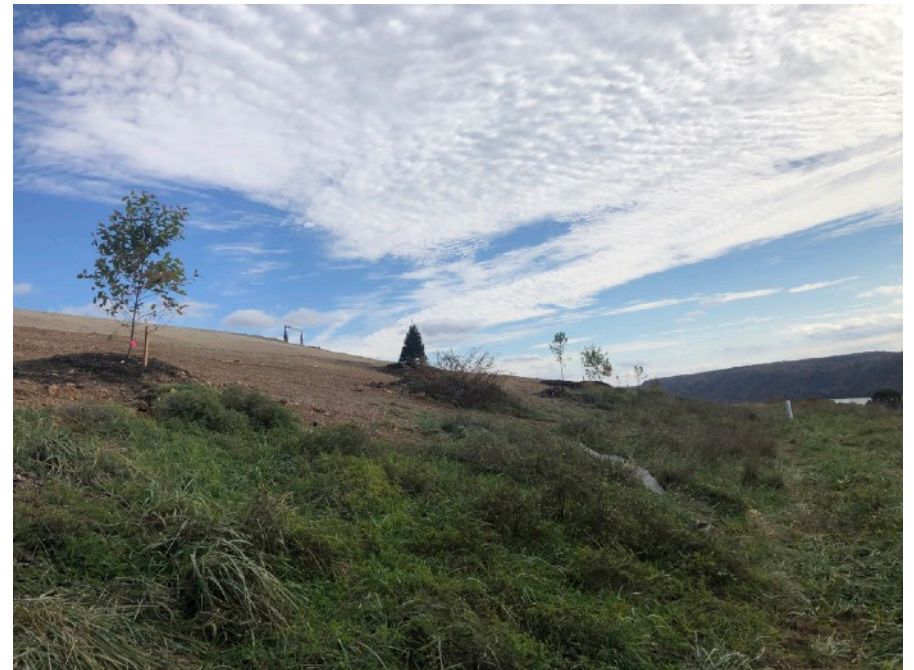
**Photos 10-14 - Fall 2020 - Replacement Plant Material (In Progress Photos)**

During Early October - Site Contractors, in an effort to cap the area directly above the northwestern edge of "Stage One" had unavoidable impact on plants 1, 2, 3, 4, 10, 16, 23, 26, 29, 31, 32, 33. In order to complete the proper capping and grading of this area, these plants were removed. LCSWMA used this opportunity to replace and mitigate the lost plant material with plant material of a larger size and caliper and with species thought to be thriving in our first year of analysis. (A list of effected plant material and replaced plant material is attached). The replacement plants were implemented during October 2020 and observed during this inspection.
